## COIT Restoration Saves Burned Apartment Complex Millions in Rebuild Costs

### The Challenge—Navigating a Trifecta of Fire, Smoke, and Water Damage

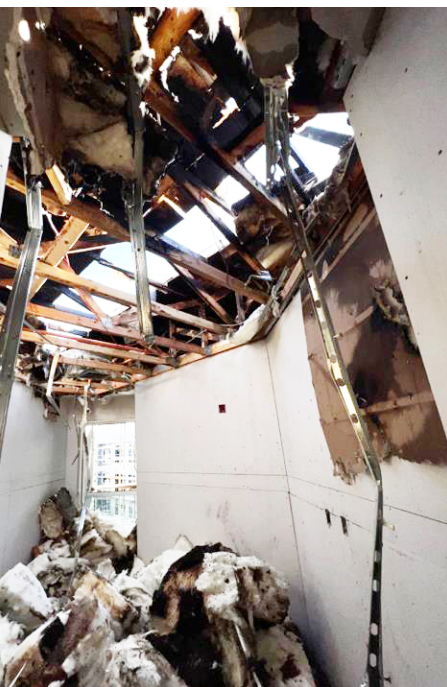
In November of 2023, a fire caused by an industrial diesel-fueled heater wreaked havoc on a Reno apartment complex that was still under construction. The fire initially started on the fourth floor but quickly blazed its way to the third and fifth floors, burning through the roof. Because there was no way to shield the inside from the elements, 93 units experienced severe water damage, contributing to a litany of restoration challenges.

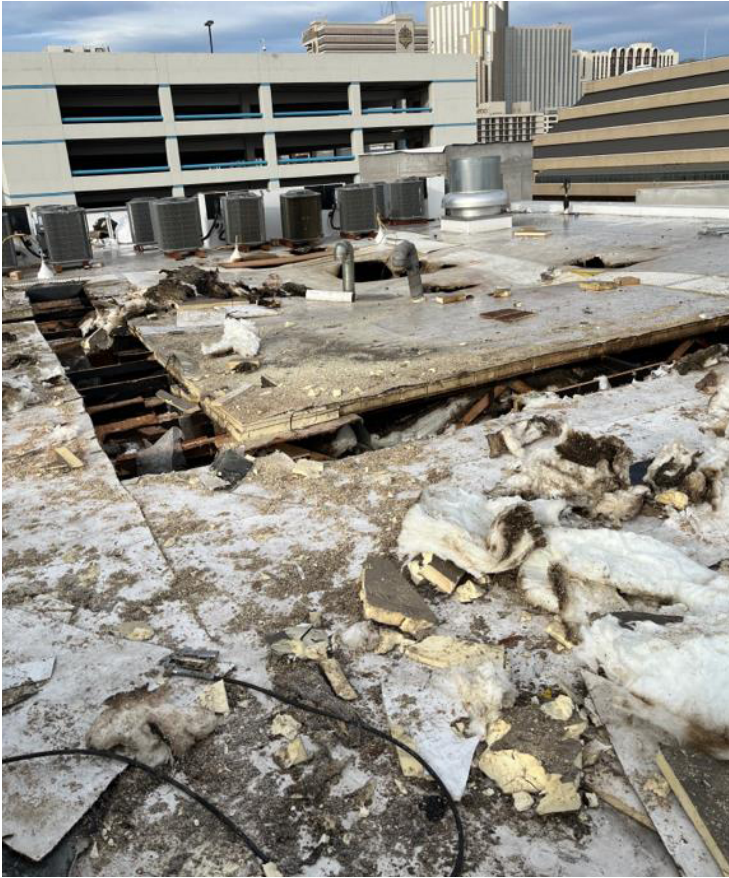
*Although most burn damage was observed on the top floors, extensive smoke damage, soot deposits, char, and carcinogens were also detected on the third, second, and first floors.*

*Particulates such as these are toxic, so to ensure the units and hallways would be safe for future residents—and to keep workers out of harm's way during the rebuilding process—these particulates would need to be contained and removed before anyone could proceed.*

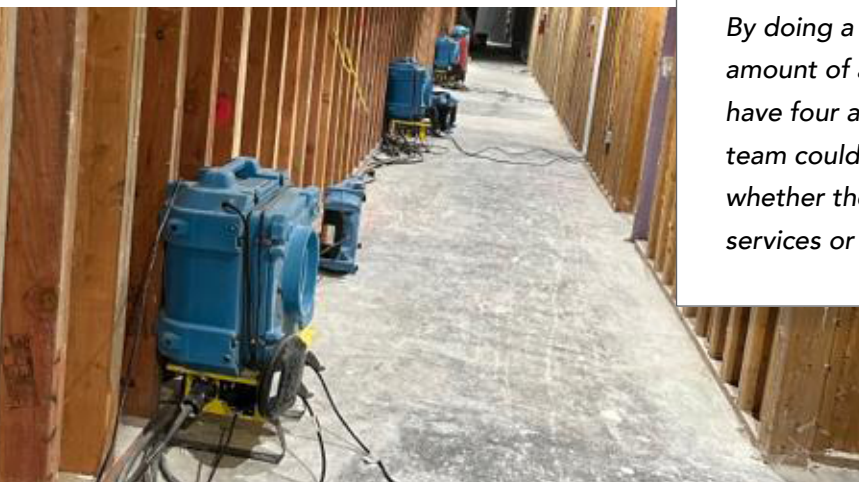
*By doing a simple calculation, the team could determine the amount of air scrubbing and negative pressure needed to have four air changes per hour. From there, the restoration team could make their way through the building, determining whether the area required full demolition and clean-up services or only needed to be cleaned.*

To ensure none of the existing particulates or odors would end up back in the cleared, non-burned side of the building, they created a negative pressure plan which consisted of over 296 air scrubbers and air movers, directing all airflow toward the fire-damaged areas and out the windows.

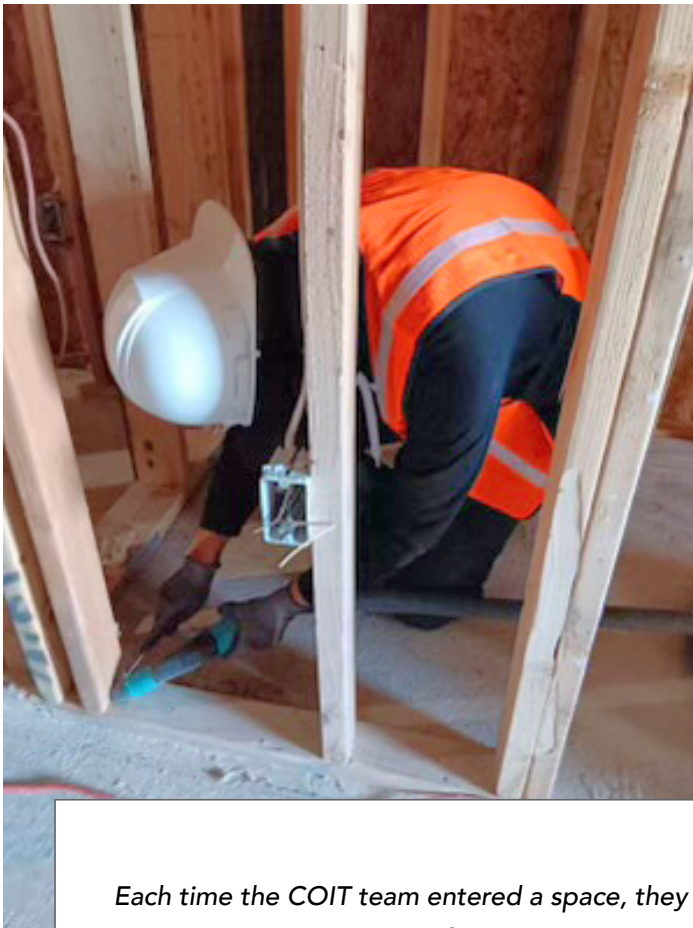
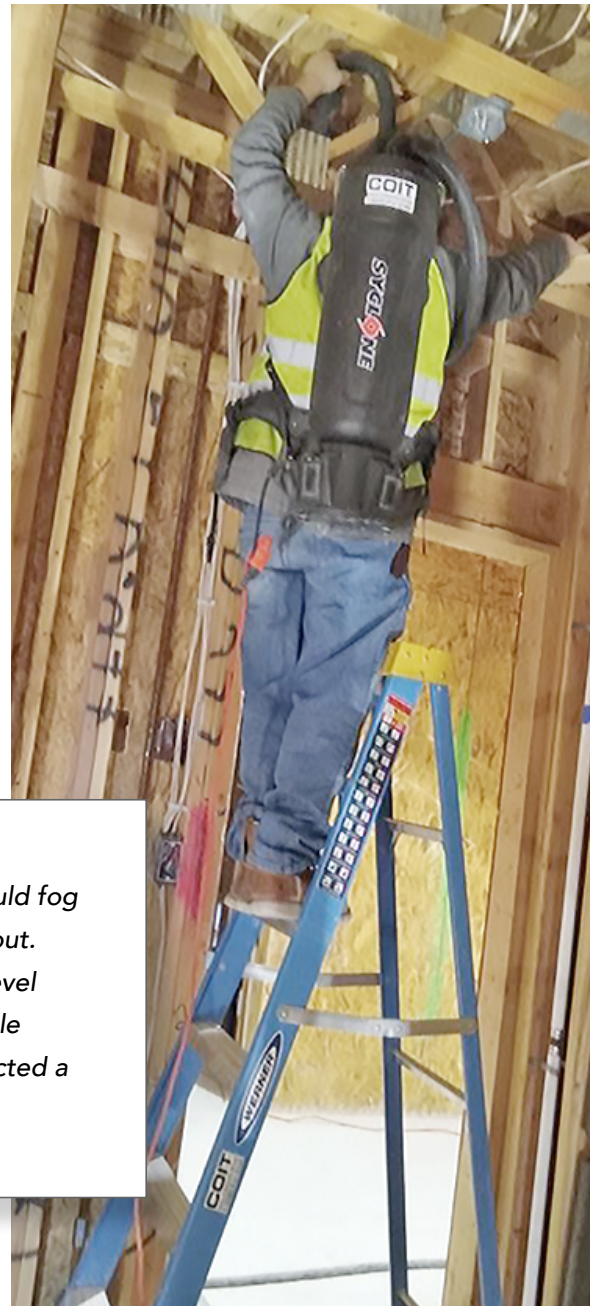
*Each time the COIT team entered a space, they would fog the area, clean it, and then fog it again on the way out. To remove harmful surface contaminants with low-level Polycyclic Aromatic Hydrocarbons (PAHs) and Volatile Organic Compounds (VOCs), the COIT team conducted a thermal heat clean on air shafts and elevator shafts.*

In total, 188 units required full demolition of porous materials to studs, 4,000 linear feet of hallway needed a full demolition of porous materials to studs, and 188 shower tub combo units were removed. For every square inch of the studs, walls, ceilings, and floors, the cleaning process consisted of a HEPA-filtered vacuuming and wet wipe with smoke odor counteractant until each zone was cleared by the industrial hygienist.

In areas where there was no sign of char and the wood was deemed salvageable, technicians dry ice blasted and smoke-sealed it, completely removing any soot and restoring the wood, which was then signed off by structural engineers.
